# FOULING AND CONTAMINATION OF SENSORS

Markus Riihimäki (UOulu), Veijo Sutinen (Cemis-Oulu),  
Timo J Manninen (Valmet)

MMEA Wastewater treatment seminar Environmental Services Authority  
Viikinmäki wastewater treatment plant

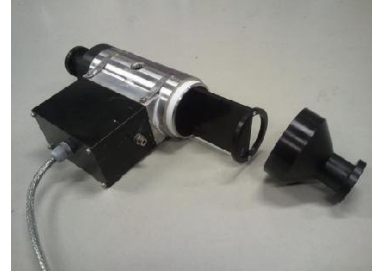
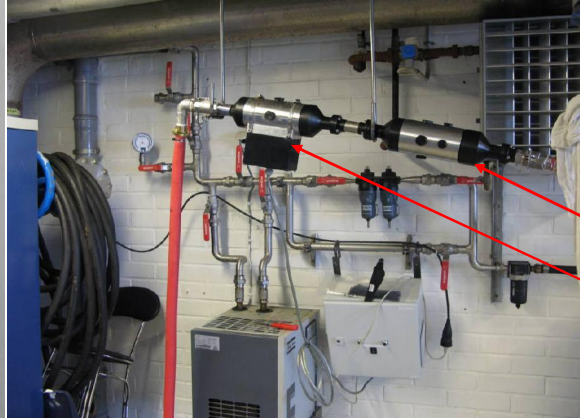
# TASKILA SET-UP

- Surface material and ultra sound tests at Taskila waste water plant in Oulu
  - Reject water from sludge centrifuges
  - 10 coatings: 9 for metals, 1 optical for sapphire glass
  - Test with and without ultrasound
  - Measurement of fouling after a test period c.a. 2,5h: visual, microscopy, and absorbance measurement for fouling detection
- Chemical analysis from deposited material: SEM-EDS (microanalysis for elements), IR-DRIFT (chemical identification)

ASA 116 halk. 25 mm paksuus 8 mm					
AR229 (A)	AR229 (A)	AR112 (A)	YO (A)	PFA-ATV (A)	REF1 (A)
21,251 g	23,409 g	23,219 g	23,143 g	23,187 g	23,020 g
AR229 (B)	AR229 (B)	AR112 (B)	YO (B)	PFA-ATV (B)	REF1 (B)
21,269 g	19,760 g	23,017 g	23,107 g	23,288 g	23,167 g
					REF2 (A)
					23,046 g
					REF2 (B)
					23,139 g

Safirilas halk. 25mm paksuus 6mm			ASA 116 halk. 25 mm paksuus 2 mm			
YO (3)	REF (1)	Zn (A)	DiC film (A)	Si-DiC (A)	TiCN (A)	
11,487 g	11,645 g	7,751 g	7,758 g	7,737 g	7,711 g	
YO (4)	REF (2)	Zn (B)	DiC film (B)	Si-DiC (B)	TiCN (B)	
11,482 g	11,696 g	7,760 g	7,799 g	7,787 g	7,711 g

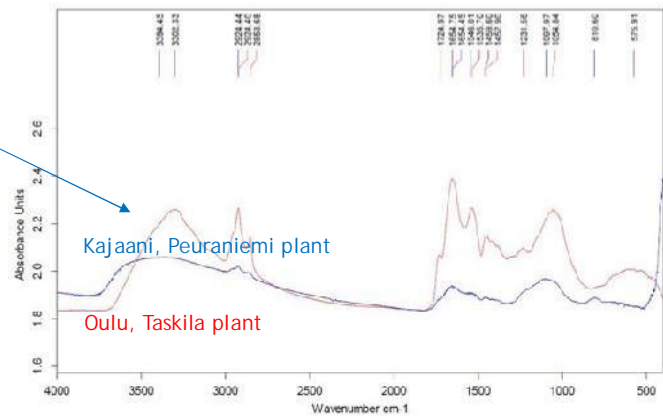
# CHEMICAL ANALYSIS OF DEPOSITED MATERIAL

Element	Weight %	Atomic%
O K	8.82	71.76
Al K	0.41	2.00
P K	0.34	1.44
S K	0.12	0.48
Ca K	0.27	0.87
Fe K	10.07	23.45
Totals	20.03

- **Particles**, X-ray microanalysis → Iron oxides
- **Transparent deposit**, IR-FTIR → waxes and fatty acids

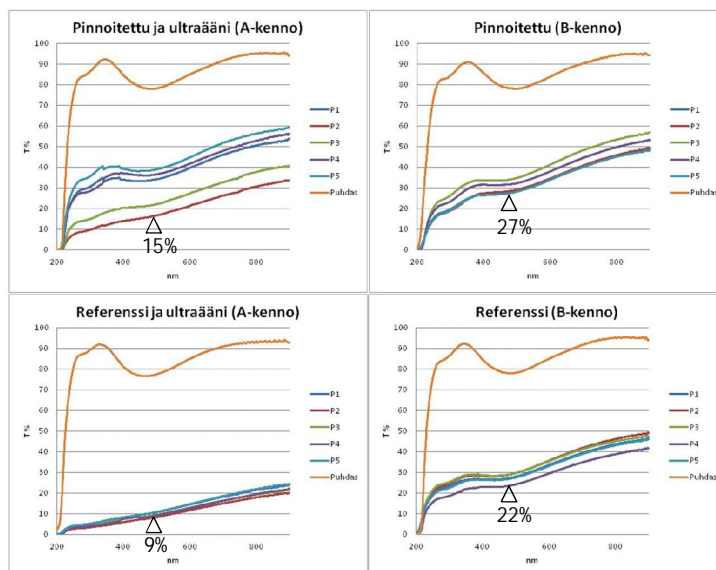
# TRANSMITTANCE

- With ultrasound transmittance dropped more than in ref
- With optical coating transmittance dropped less both with ref and ultrasound

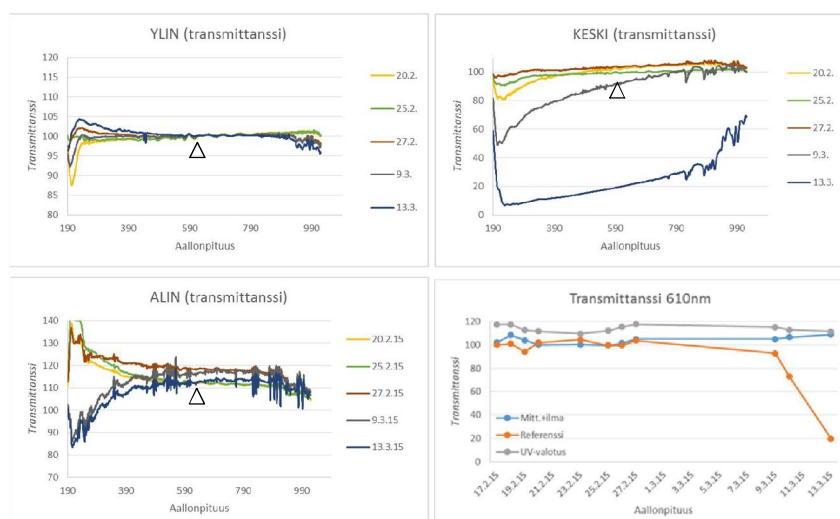
## TEST 1 PEURANIEMI PLANT IN KAJAANI

- Top (air-jet) and bottom position (UV light) have small drop in transmittance
- Reference has marked drop especially after 3 weeks

- Aim was to find optical window fouling in plant effluent conditions
- Mitigation of fouling was tested using (1) UV light and (2) air jet
- Test periods (2) were during the spring 2015
- In the first test period UV light and air jet was found to mitigate fouling
- In the second test fouling was slow and no clear differences
- Further testing of UV light could be beneficial because in normal operation of waste water plant it was found to mitigate fouling effectively

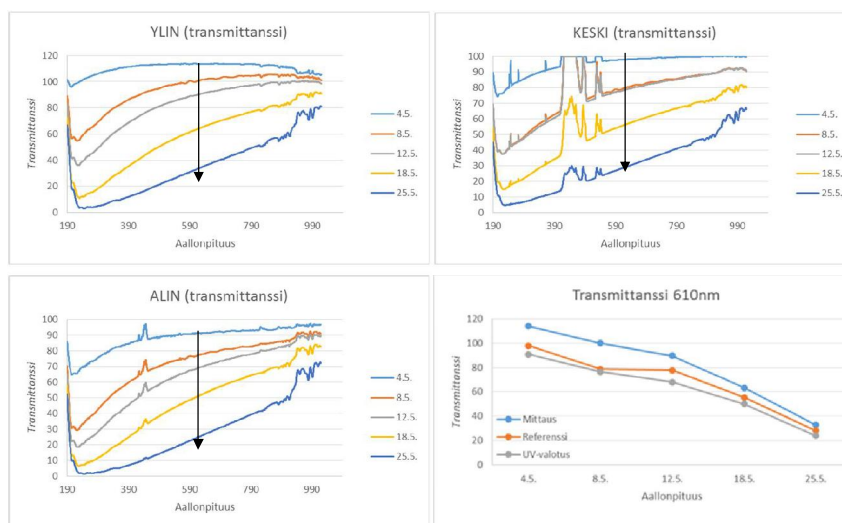
## TEST 2 PEURANIEMI PLANT IN KAJAANI

- During test period 2 fouling was weak and difference between UV, air-jet and reference could not be made
- Test period 2 was during spring having flood waters: high flow and low P
